FACILITY COMPLIANCE INSPECTION REPORT

Date of Site Inspection: September 9, 2014

Roaring River Municipal Solid Waste Landfill Facility
 9219 Elkin Highway
 Roaring River, North Carolina 28669

Comprehensive Inspection

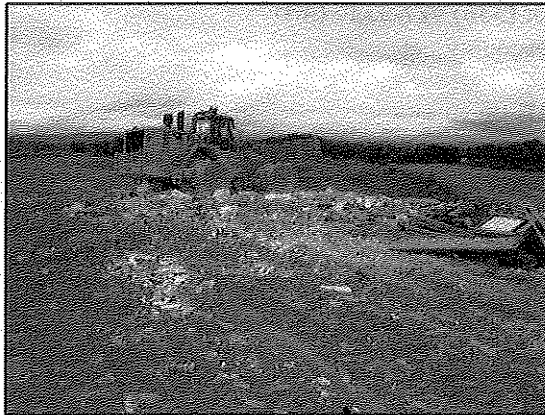
During the inspection, a load of waste was dumped at the working face that included a sign that read "County of Burke Environmental Offices." The facility is not permitted to receive waste from Burke County. Therefore, Wilkes County is in violation of 15A NCAC 13B .1626(1)(a), 15A NCAC 13B .0203(d) and General Facility Permit Condition #8.

View of waste site with "County of Burke" on right of photo.

To achieve compliance, within **10-days** of the receipt of the Notice of Violations, the origins of the waste load must be verified and Wilkes County must submit a written response to the Solid Waste Section detailing what actions will be taken by the county to prevent acceptance of waste from outside the approved service area for the facility. This can include, but not be limited to changes to the waste screening process to recognize waste generated from outside of the approved service area for the facility.

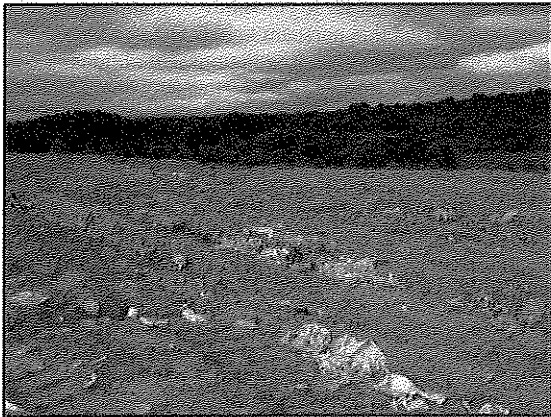
During the inspection, insufficient cover was observed over a large portion of the landfill cell leaving waste exposed. Areas of concern included inactive areas west of the current working face, south of the working face near the new slope drain installed over the inactive south slope, and slightly north on the previous waste lift. Exposed waste was also observed in eroded gullies north of the current working face near the northern extent of the landfill and on the western slope of the landfill near an existing slope drain. Therefore, Wilkes County is in violation of 15A NCAC 13B .1626(2)(a), 15A NCAC 13B .0203(d), and General Permit Condition #6.

View of exposed waste west of working face.

To achieve compliance, all exposed waste must be covered with a minimum of 6-inches of earthen material within **10-days** of receipt of the Notice of Violation. Areas which will not have additional wastes placed on them for 12-months or more, but where final termination of disposal operations has not occurred, shall be covered with a minimum of 1-foot of intermediate cover.

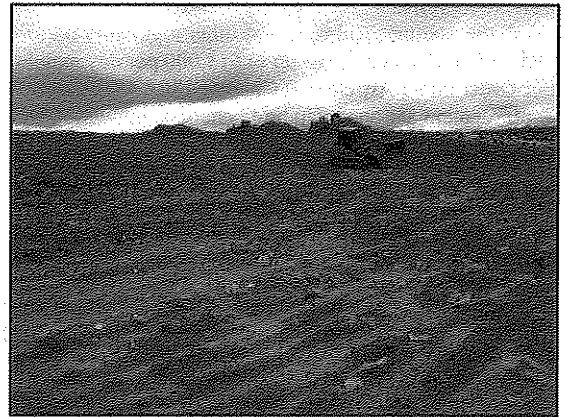
View of exposed waste north of working face.

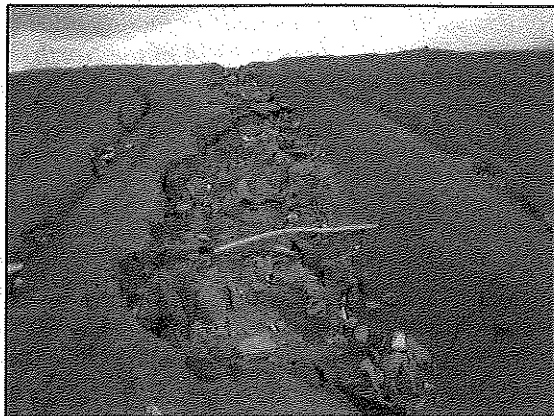
During the inspection, severe eroded gullies were observed north of the working face resulting in waste being exposed. Therefore, Wilkes County is in violation of 15A NCAC 13B. 1626(7)(b).

View of erosion of slope exposing waste.

To achieve compliance, within **10-days** of receipt of the Notice of Violation, adequate sediment control measures (structures or devices) must be installed to prevent over-wash of slopes creating severe erosion that is leading to exposure of waste. Also, as required under #2 above, all eroded gullies north of the working face must be covered with appropriate earthen material within **10-days** of the receipt of the Notice of Violations.

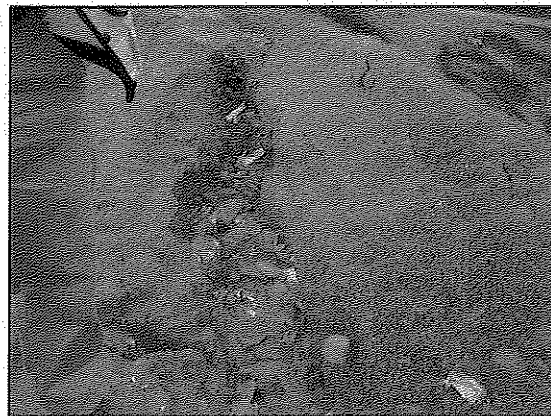
Erosion with exposed waste at far north side of landfill.

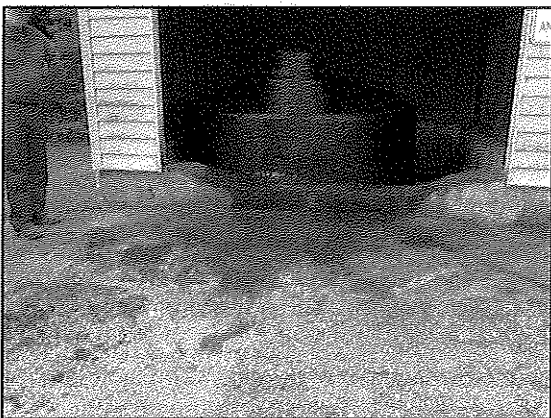
31. The facility provides a convenience area west of the scalehouse with multiple roll-containers to allow the general public to dispose of municipal solid waste without having to enter the landfill. During the inspection, waste was observed on the ground surrounding the roll-off containers including a heavy buildup of small particulate waste and residue. Please ensure that any waste that falls to the ground surrounding the containers is immediately picked up and placed in the container.
32. During the inspection, a heavy oil stain was observed on the asphalt in front of the designated disposal area for used oil and antifreeze, outside of the secondary containment area. A storm drain is located approximately 20-feet from the oil collection area.
 - This condition has been referred to Carin Kromm, Supervisor, UST Section at the Winston-Salem Regional Office.

View of oil laden stain on asphalt.

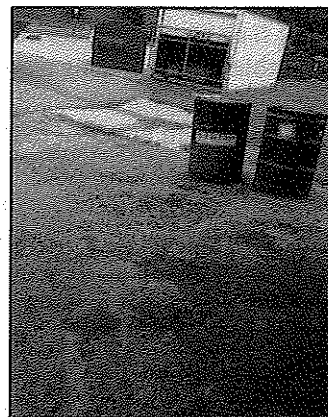
View of storm drain near oil collection area.
